Jetty Structural Survey

Description of Works

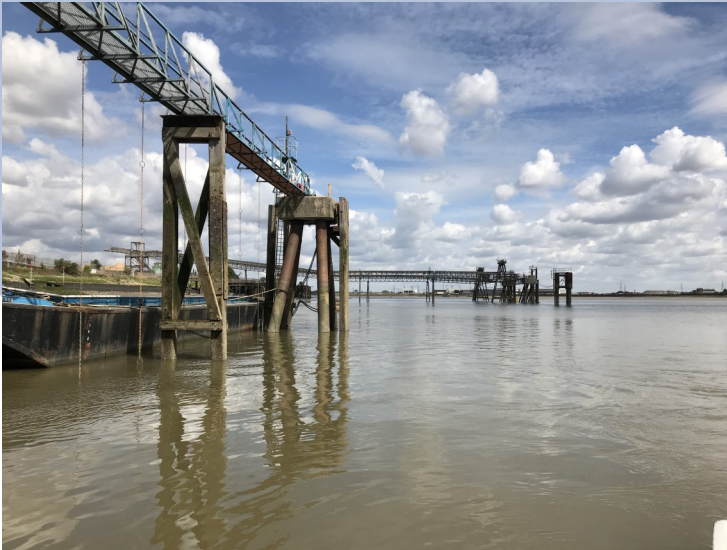
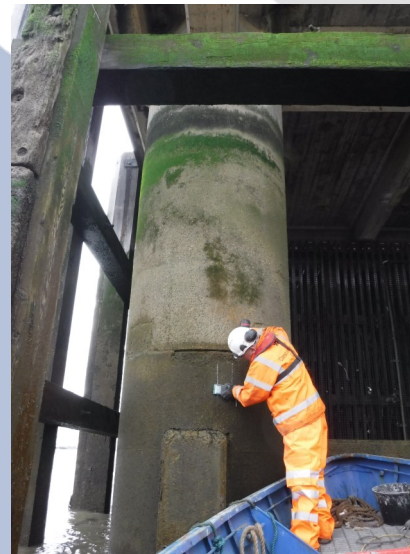
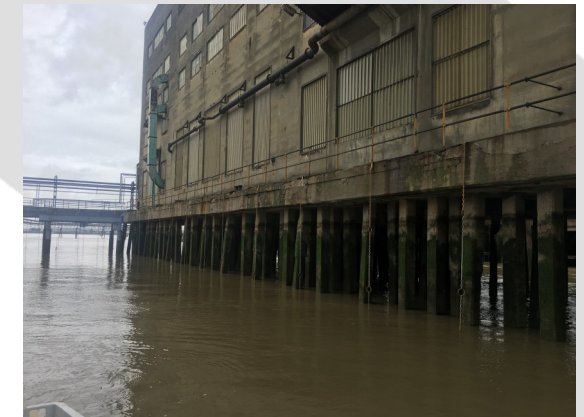
The diver survey found a large crack and a substantial area of missing concrete to a pile just below some cross bracing. This was troubling because if left untreated, the reinforcement in the concrete; now exposed to the salt environment, would heavily corrode and therefore be at risk of compromising the structural integrity. Fortunately, we discovered this before any issues could arise and the client was able to take actions to rectify the problem.

Other works included Cover and carbonation testing, Ferrosscanning, Chloride Ion testing, Schmidt Hammer Testing and Concrete Coring. All tests found evidence of corrosion to exposed reinforcement. Whilst this isn't news a client would be happy to hear, it is to be expected in environments exposed to salt spray. It also meant that our client was able to take preventative measures to rectify the problems, rather than the much more undesirable reactive measures.
